## The Use of ACell Vet™ for Repair of a Degloving Injury in a Canine.

Submitted by Jeffrey D. Wood, DVM,  
[Northside Veterinary Hospital](#), 1091 W. Moore Rd., Hillsdale, MI 49242

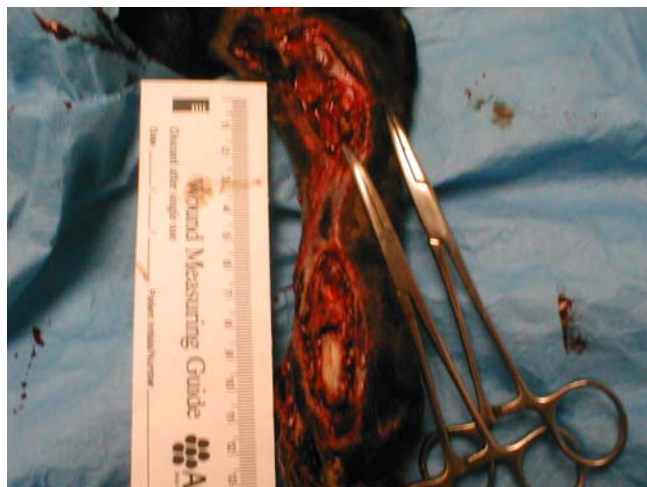
"Dudley", a 13 month male neutered Labrador Retriever mix presented on October 11, 2002 (photo # 1) with a classic "degloving" injury to the dorsal metatarsal as well as transverse fractures of 2nd and 3rd phalanx.

Following gentle cleansing of wound, a single ply layer of the lyophilized ACell Vet bio-scaffold was cut to size and applied to the largest void. The ACell Vet material was then covered with a layer of saline soaked gauze, a layer of Vaseline impregnated gauze to hold in the moisture, and finally covered with a light Vetwrap (photo # 2).

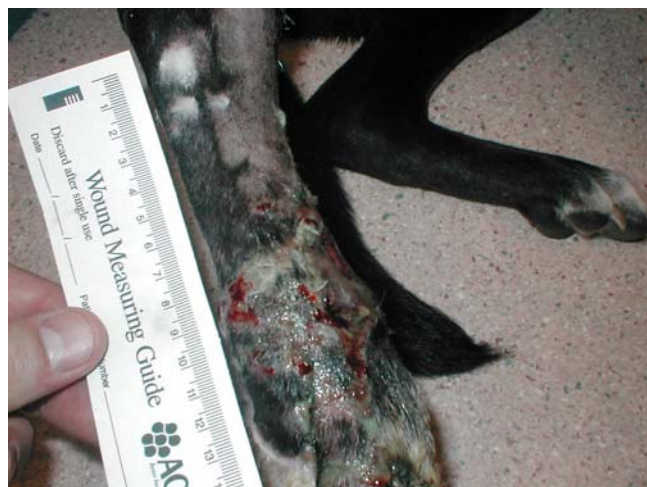
Recheck on October 14 2002 revealed excellent initial formation of granulation bed in the wound area with no sign of swelling or infection. (photo # 3). At this point, the results are so good the owner comments that he "thought treatment was complete". A second piece of the ACell Vet material is applied and bandaged as before.

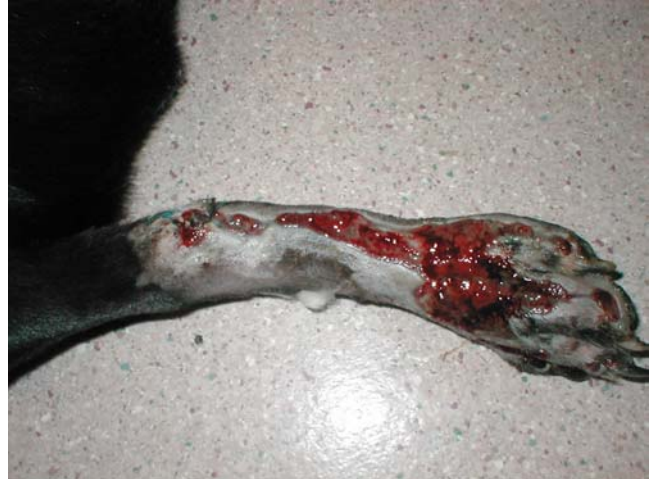
A recheck on October 22, 2002 showed continued healing, with excellent granulation bed and vascularization. At this point, no more of the ACell Vet product will be used as the wound is well on its way to healing.

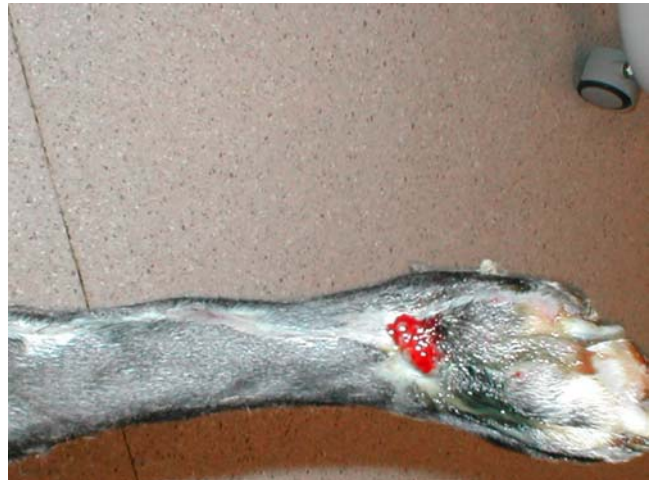
At the November 11, 2002 follow-up, the largest wound area has now contracted to approximately the size of a fingernail.

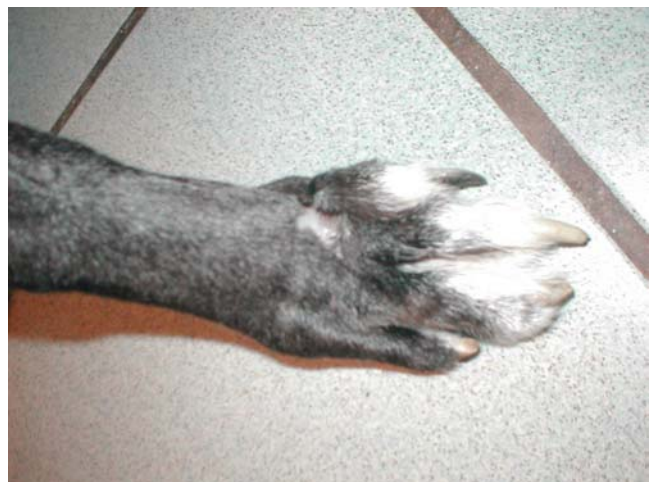
At the December 17, 2002 Dudley was in for a routine exam and the wound is now almost completely healed with hair re-growth proceeding in the wound area
